SUBJ: EPA Asbestos Removal at 235 Eden Street

REMOVAL ACTION STATUS REPORT DAVIDSON ASBESTOS

Property Address: 235 Eden Street, Davidson, Mecklenburg County, North Carolina

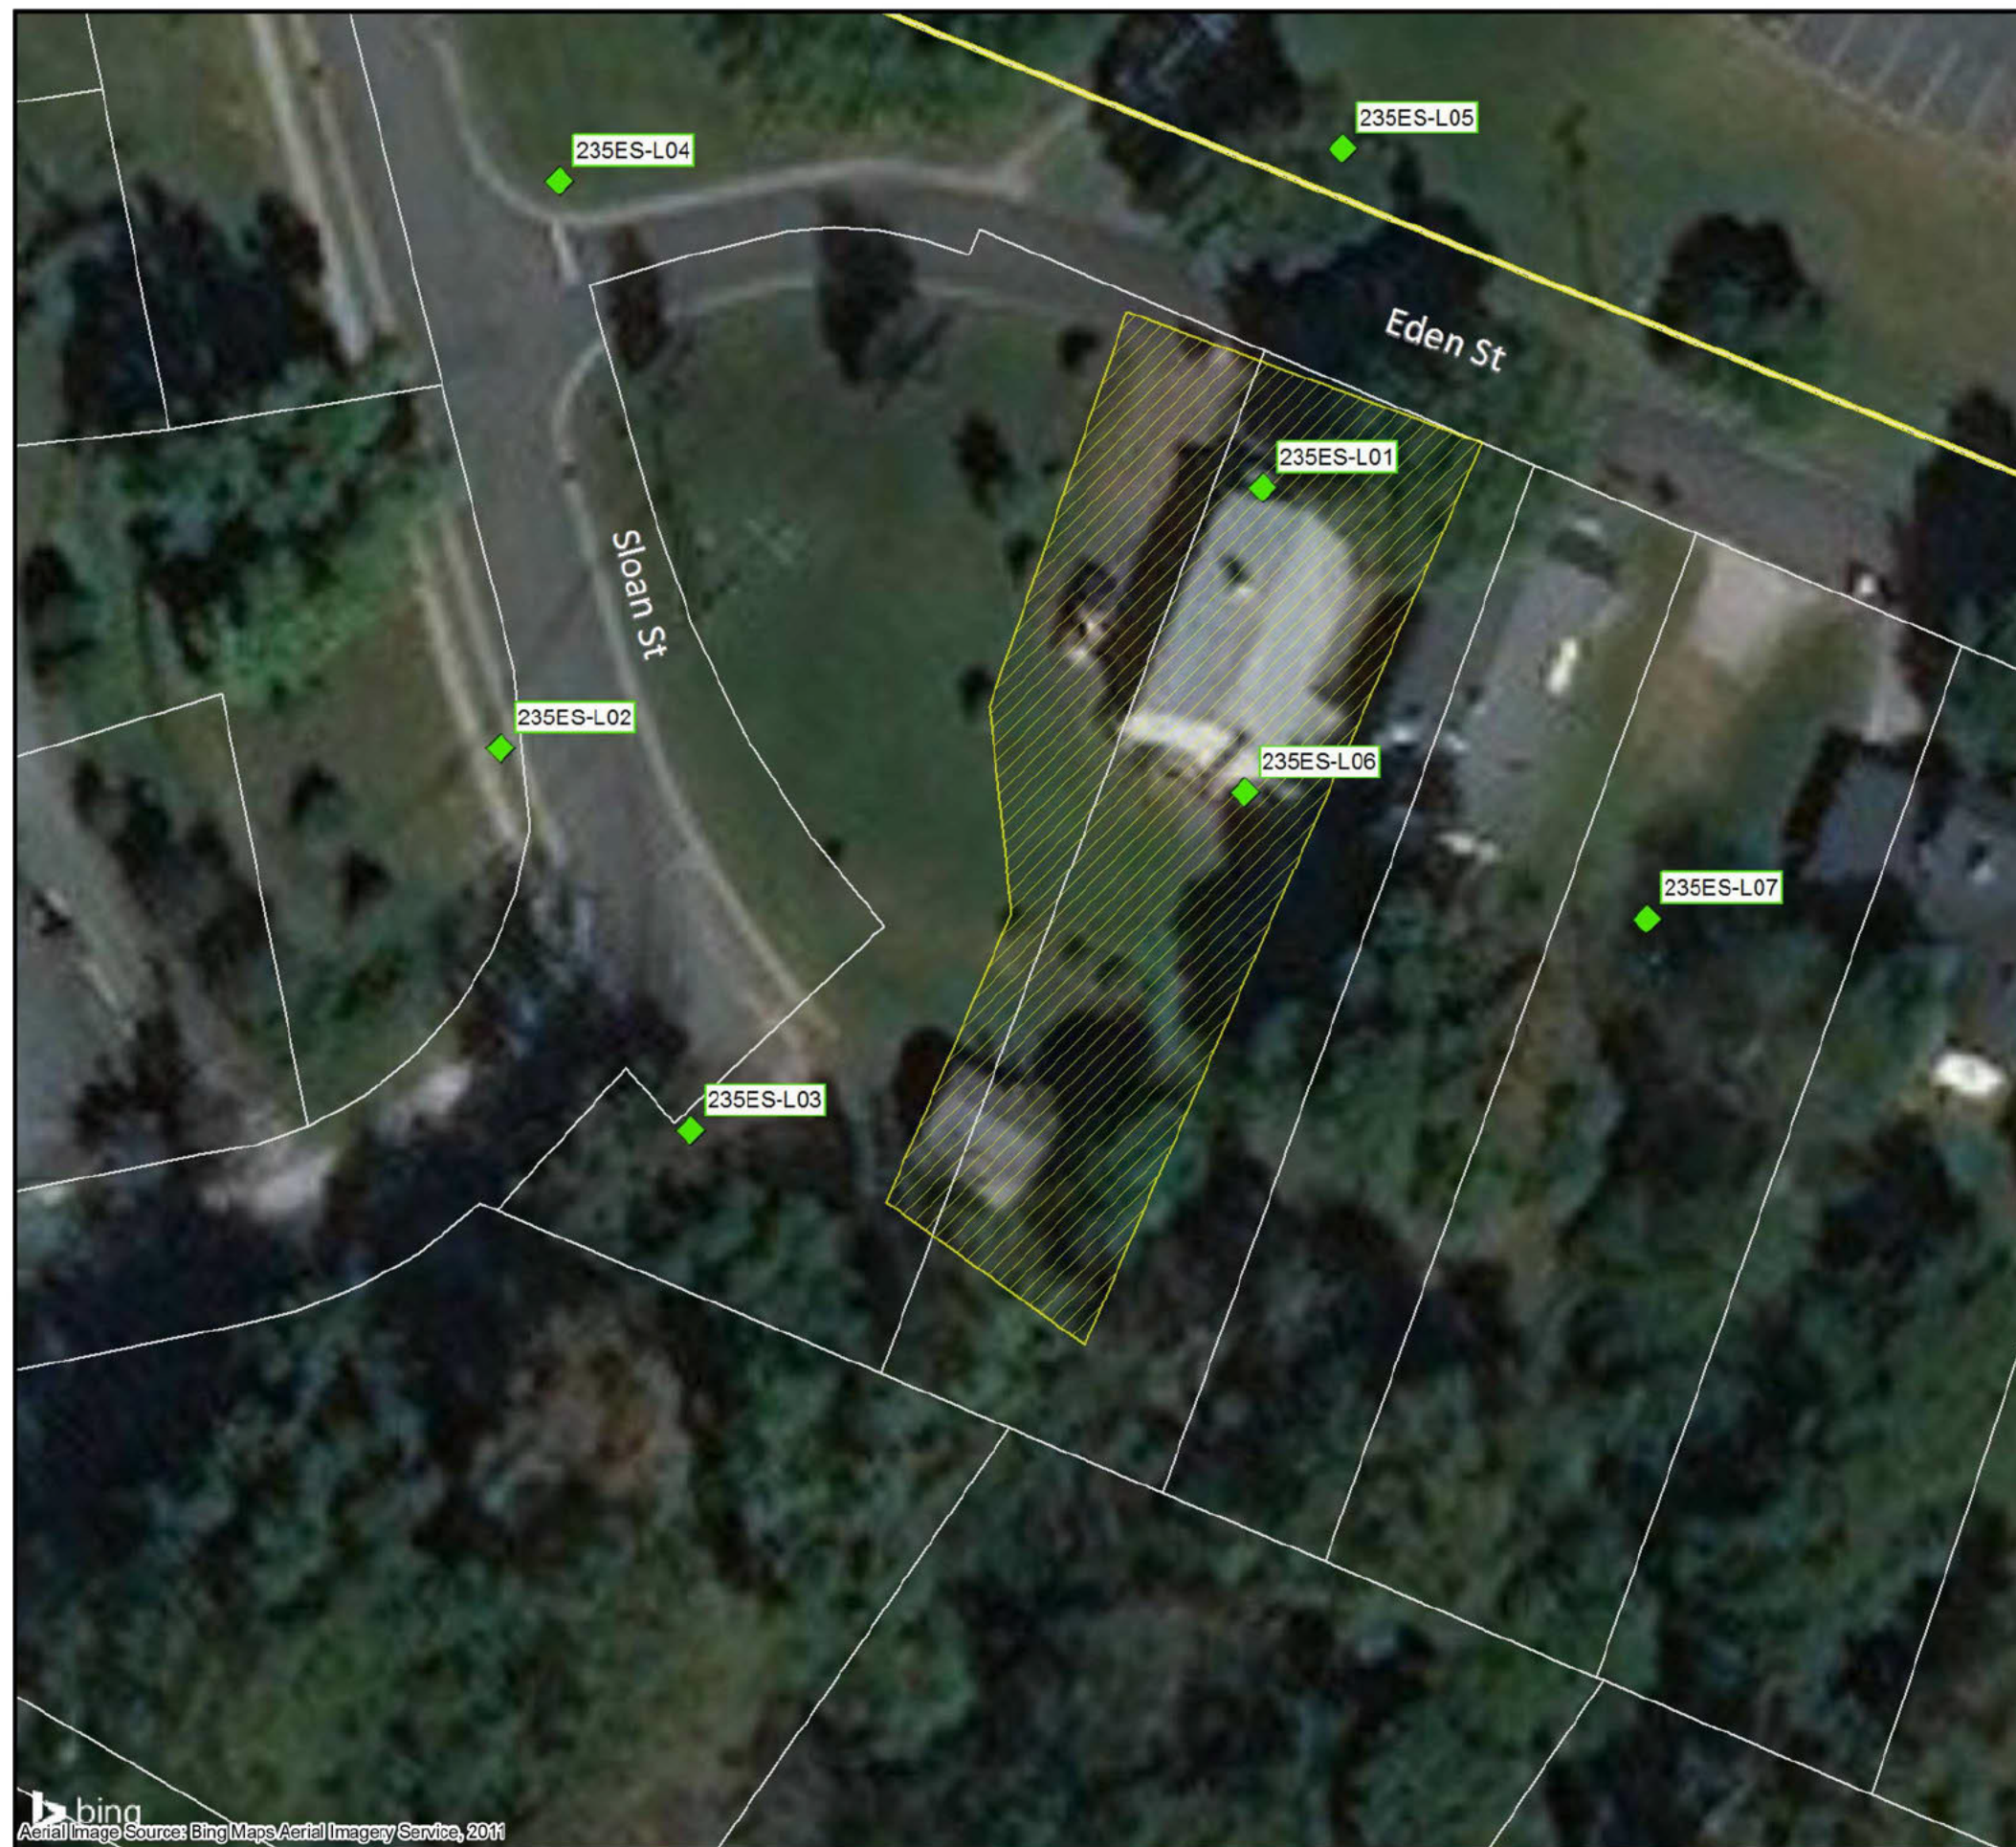
FIGURE 1

Description of Removal Action: The soil was excavated to an approximate maximum depth in the following areas: lawn to 12 inches and along the residential and southern shed foundations and the tree and shrub line areas to 3 inches (see Appendix 1). Visual inspections of the areas excavated for ACM were conducted by a State of North Carolina-accredited asbestos inspector and air monitor. Additional removal was conducted in those areas where ACM were still visibly present, except along the base of the southern shed to prevent destabilization of its foundation and past the property boundary. Once ACM was no longer visibly present throughout the main portion of the excavated area, restoration was allowed to commence. The visible, remaining ACM was photographed and documented in the site logbook before restoration began.

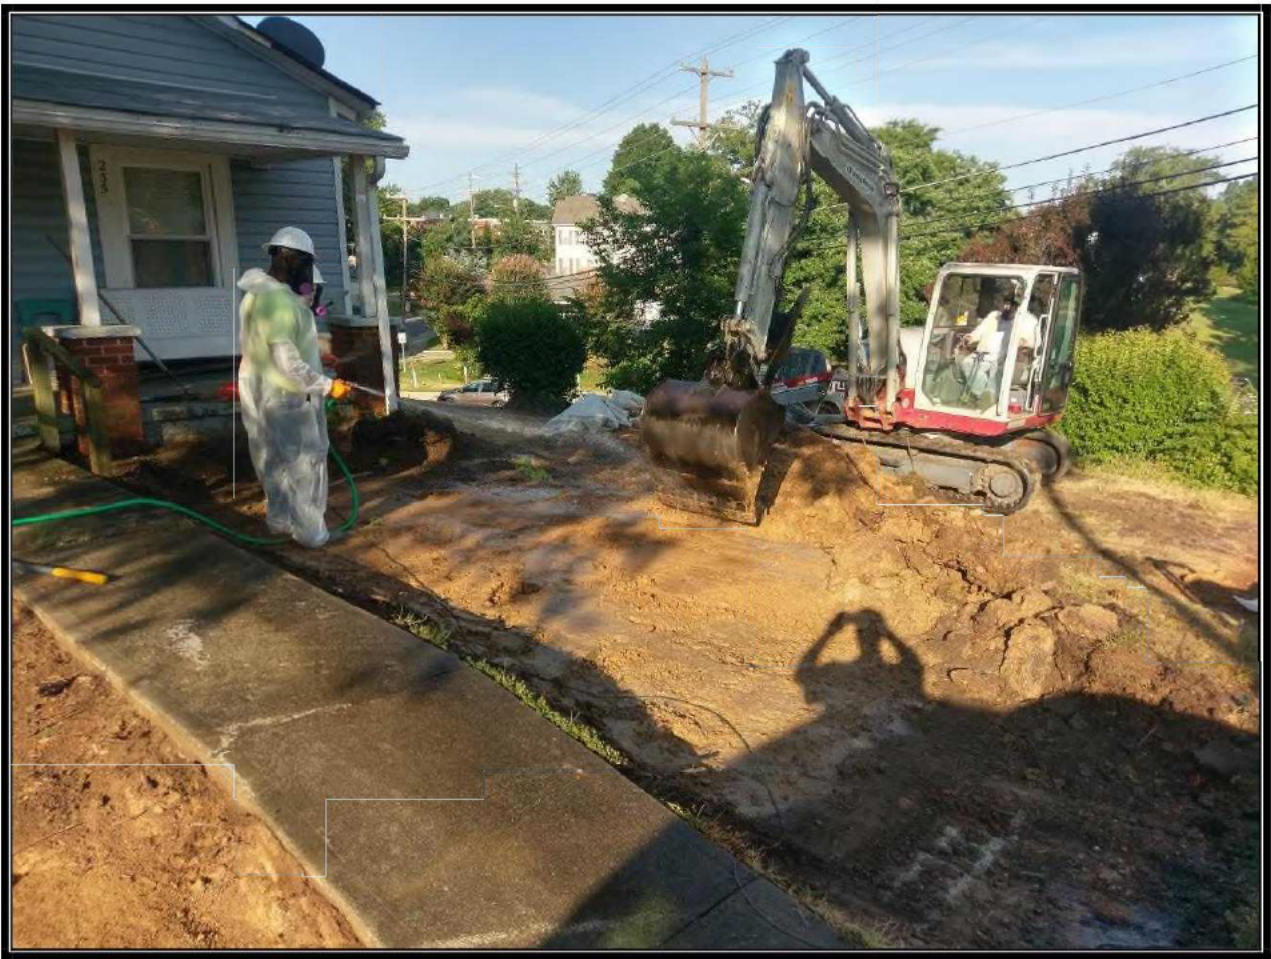
**OFFICIAL PHOTOGRAPH NO. 1
U.S. ENVIRONMENTAL PROTECTION AGENCY**

Subject: The Emergency and Rapid Response Services (ERRS) contractor, Environmental Restoration, LLC (ER), used an excavator and hand tools to remove asbestos-containing materials (ACM) and asbestos-contaminated soil from the property located at 235 Eden Street. ER used hoses to wet the asbestos-contaminated soil during removal activities.

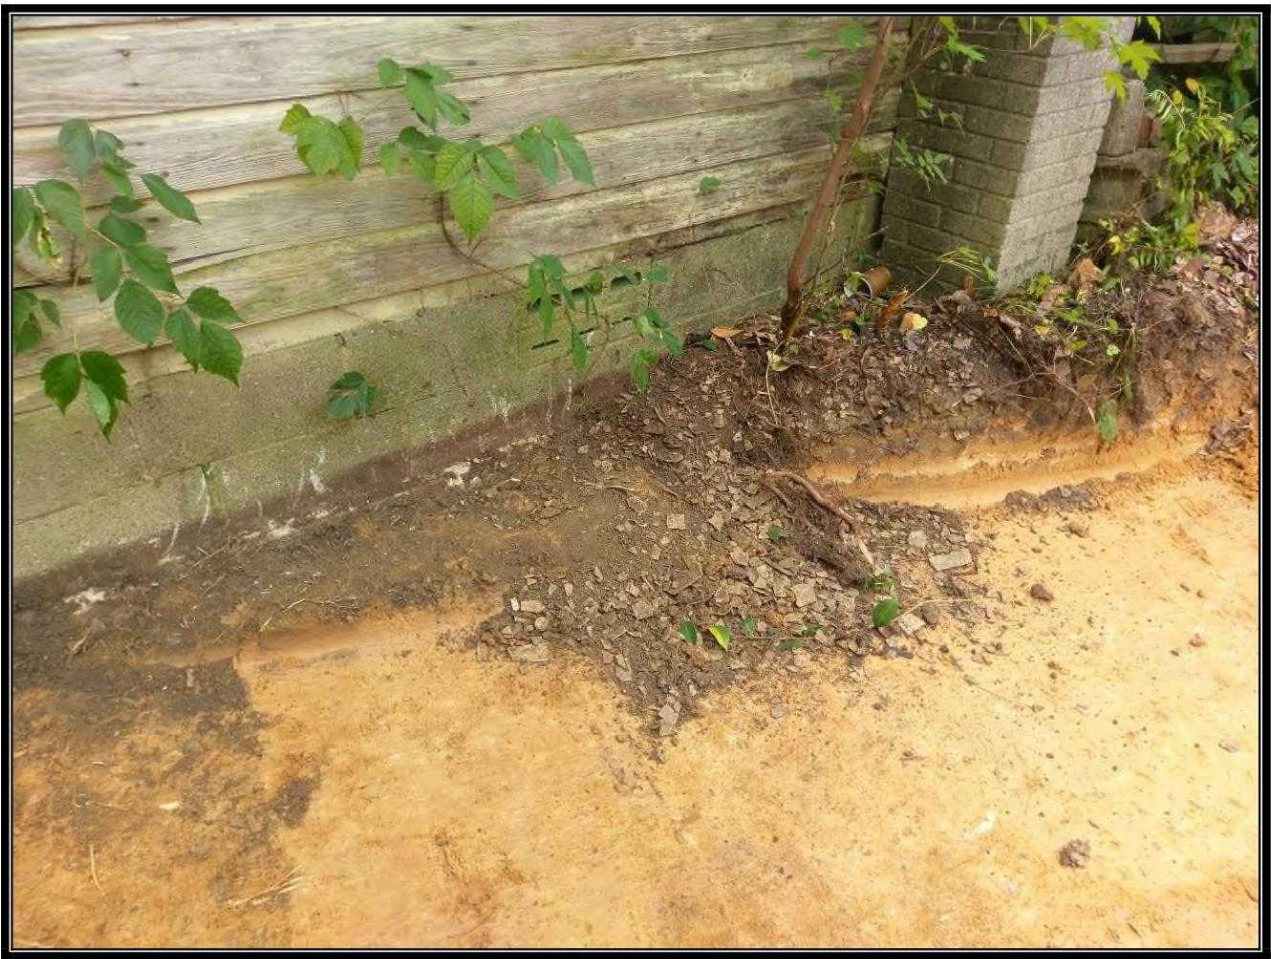
OFFICIAL PHOTOGRAPH NO. 2
U.S. ENVIRONMENTAL PROTECTION AGENCY

Subject: Tetra Tech Superfund Technical Assessment and Response Team (START), State of North Carolina-accredited asbestos inspector and air monitor, visually inspected the excavated areas for the presence of visible ACM. ER removed additional soil in those areas where ACM were still visibly present, except beneath the southern shed to prevent destabilization of the foundation or to extend past the property boundary.

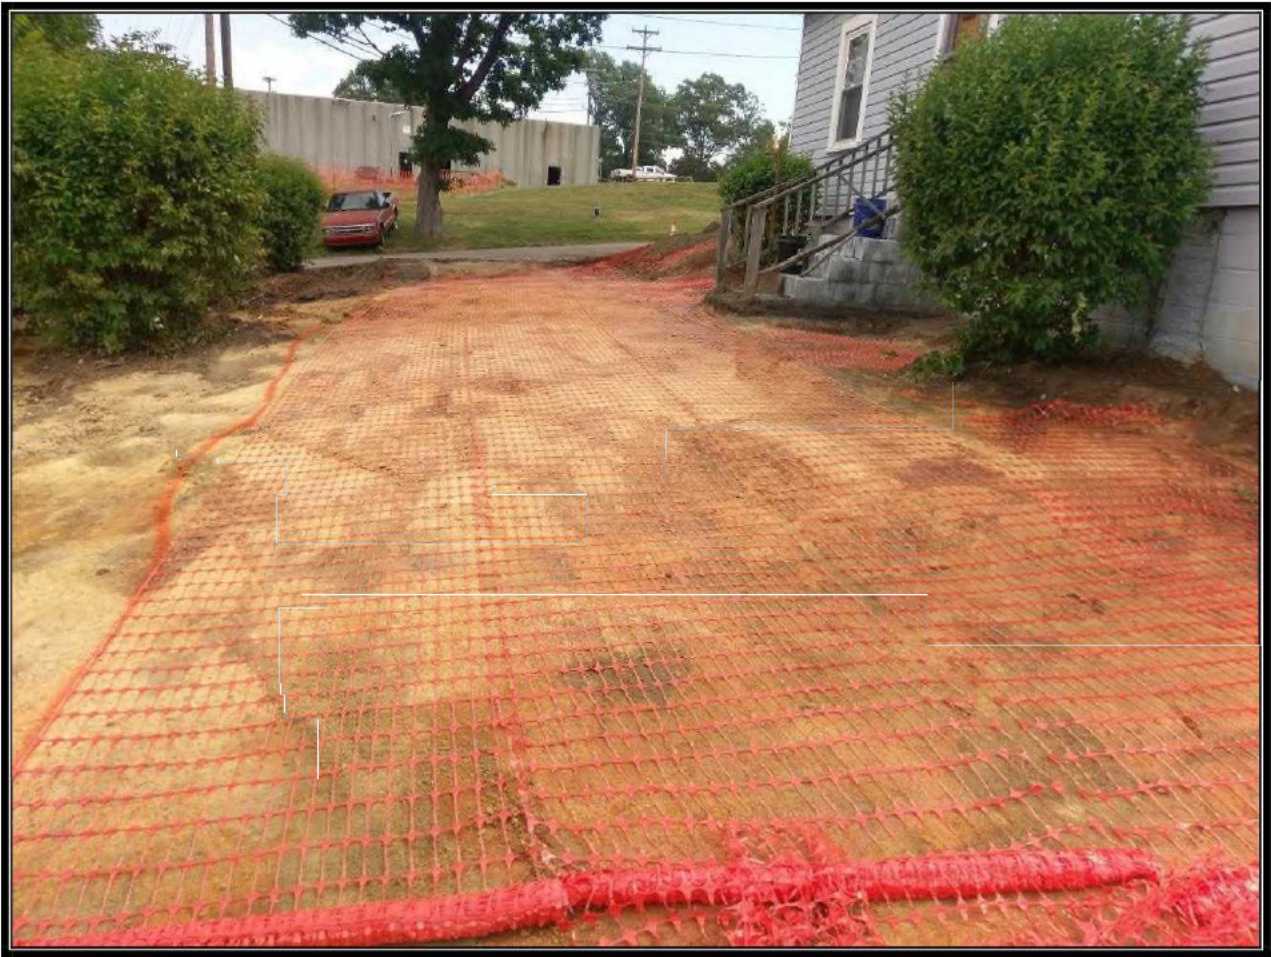
OFFICIAL PHOTOGRAPH NO. 3
U.S. ENVIRONMENTAL PROTECTION AGENCY

Subject: ER installed snow fencing along the subsurface of the excavated residential area after the visual inspection conducted by Tetra Tech START, State of North Carolina-accredited asbestos inspector and air monitor, detected no visible ACM.

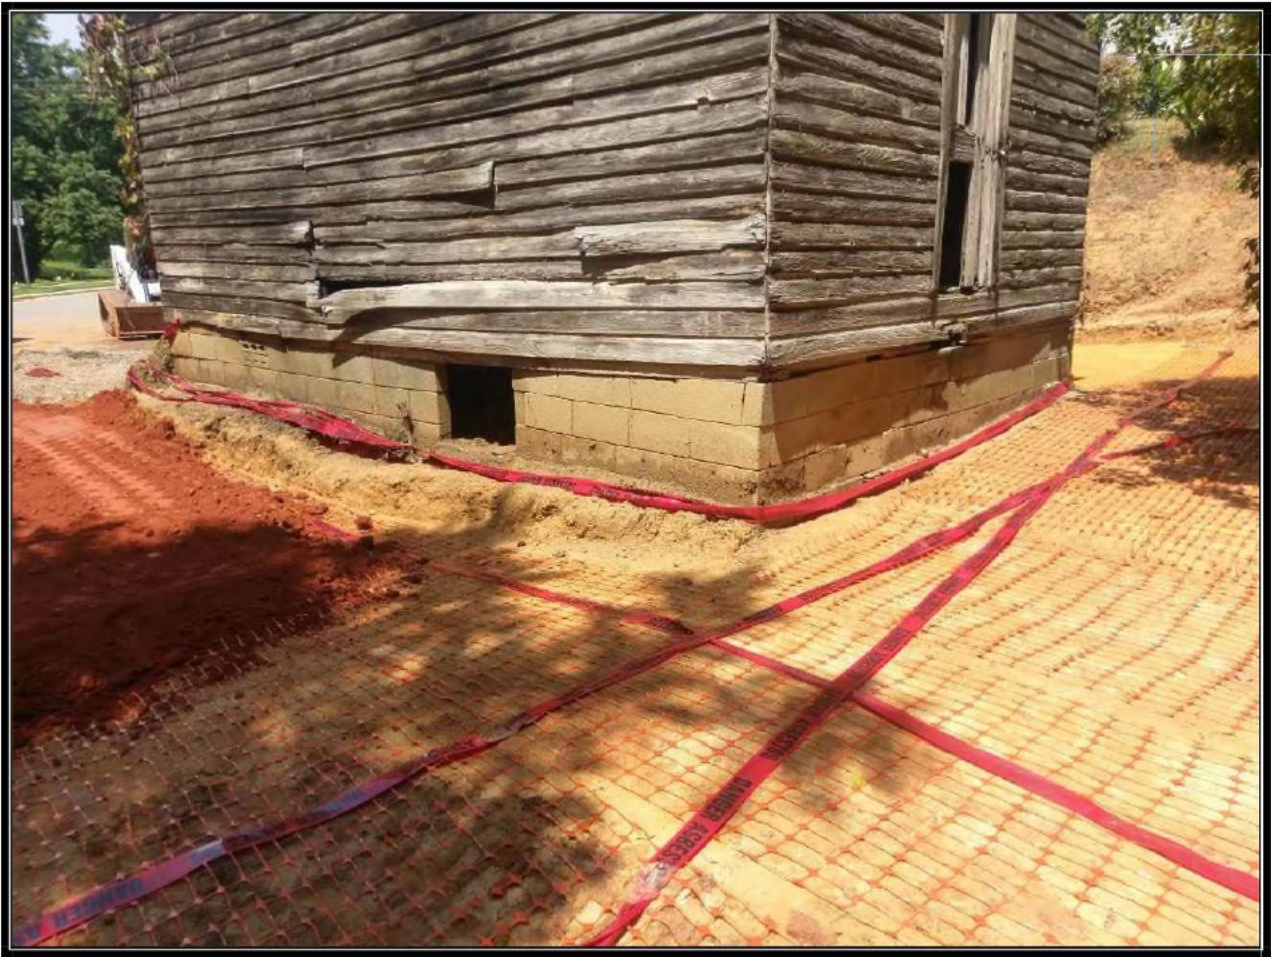
OFFICIAL PHOTOGRAPH NO. 4
U.S. ENVIRONMENTAL PROTECTION AGENCY

Subject: ER installed snow fencing and red "Danger Asbestos" tape along the subsurface of the excavated southern area to identify the depth of the excavation and the presence of ACM.

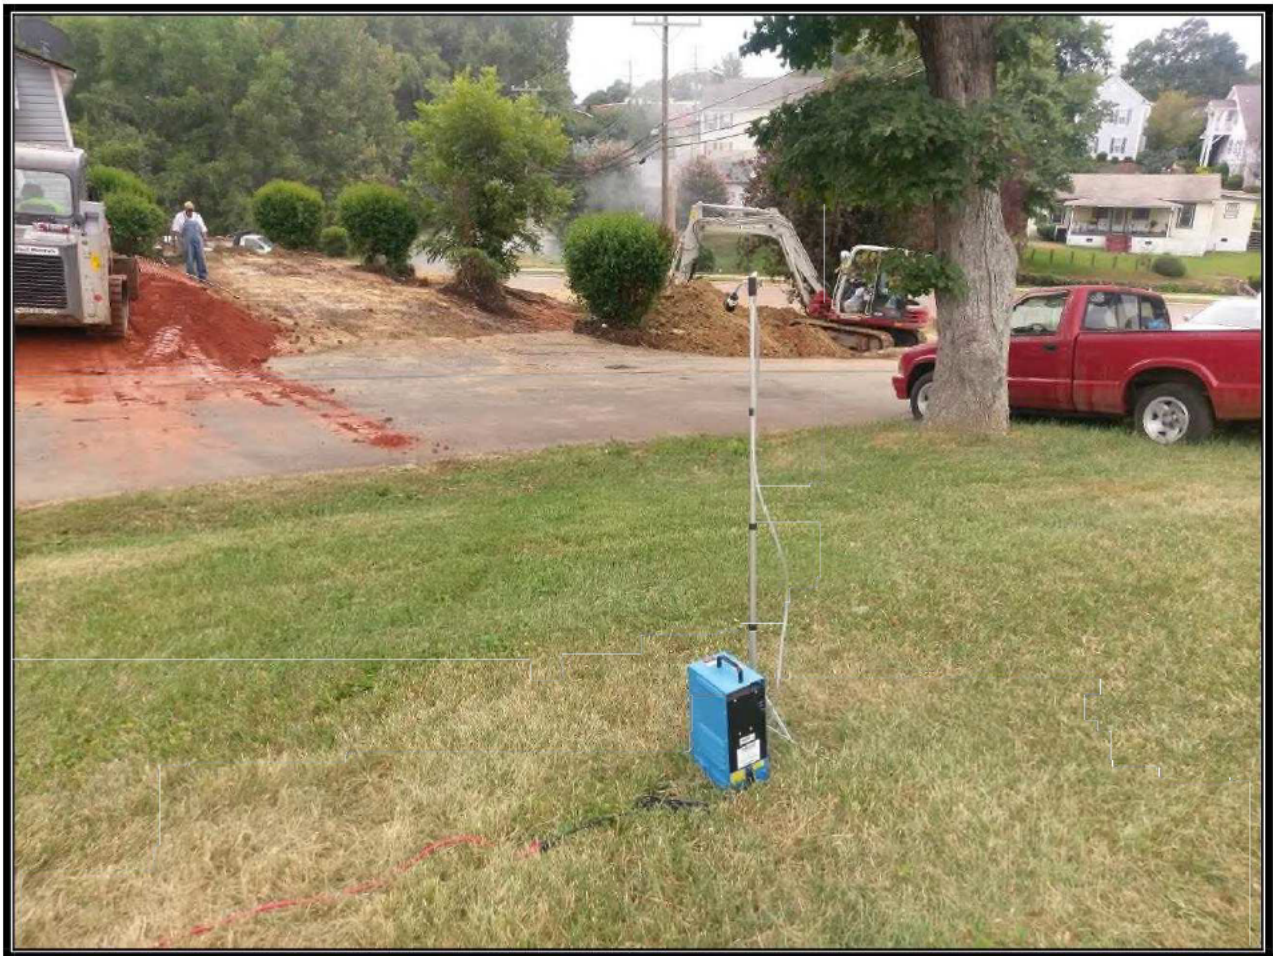
OFFICIAL PHOTOGRAPH NO. 5
U.S. ENVIRONMENTAL PROTECTION AGENCY

Subject: Perimeter air sampling was conducted by a Tetra Tech START, State of North Carolina-accredited air monitor, to evaluate the effectiveness of engineering and safety controls in preventing the off-site migration of asbestos fibers during removal activities.

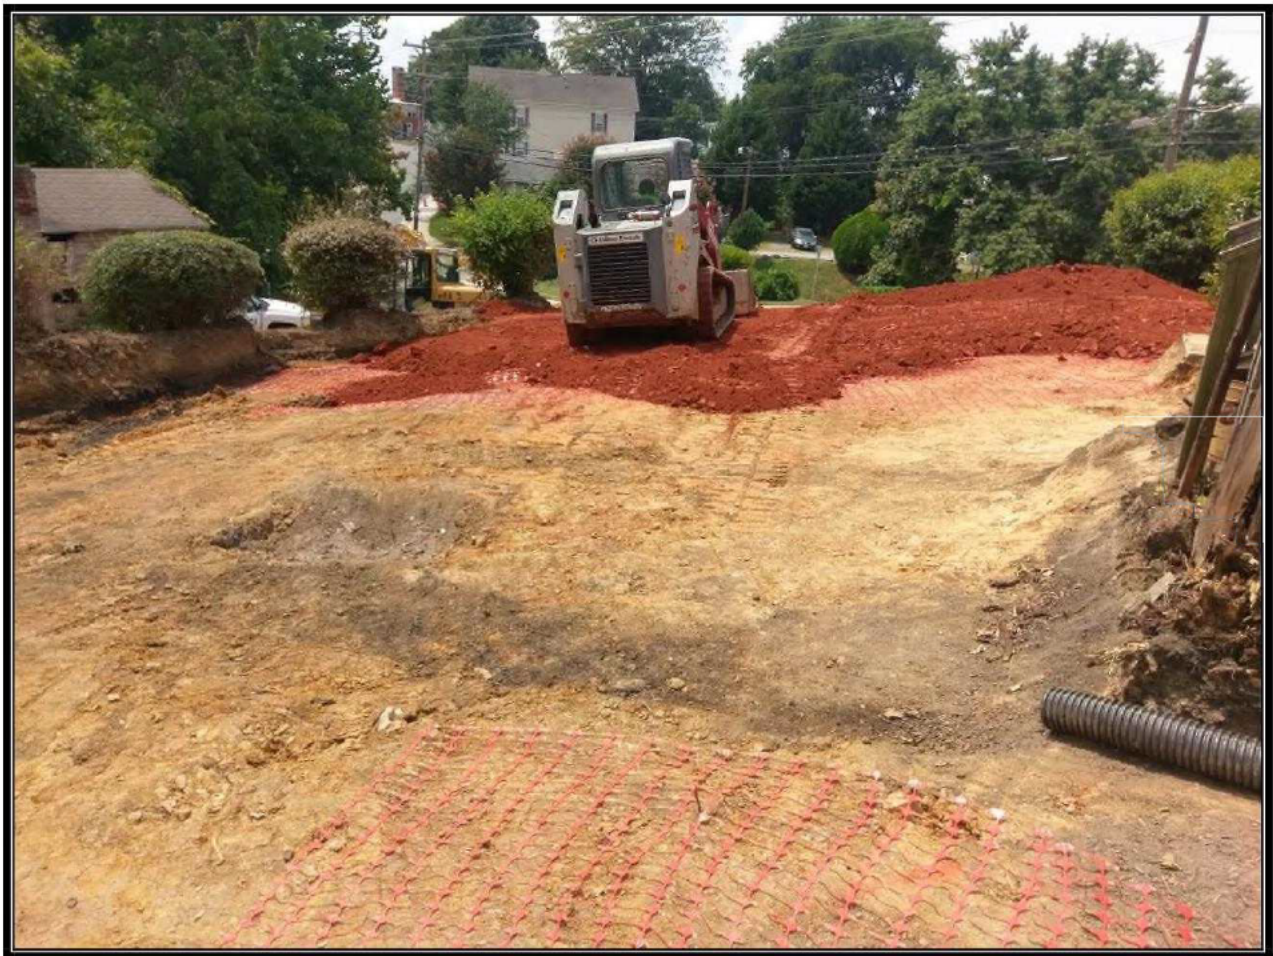
OFFICIAL PHOTOGRAPH NO. 6
U.S. ENVIRONMENTAL PROTECTION AGENCY

Subject: ER installed backfill in the excavated areas using dump trucks and skid steers.

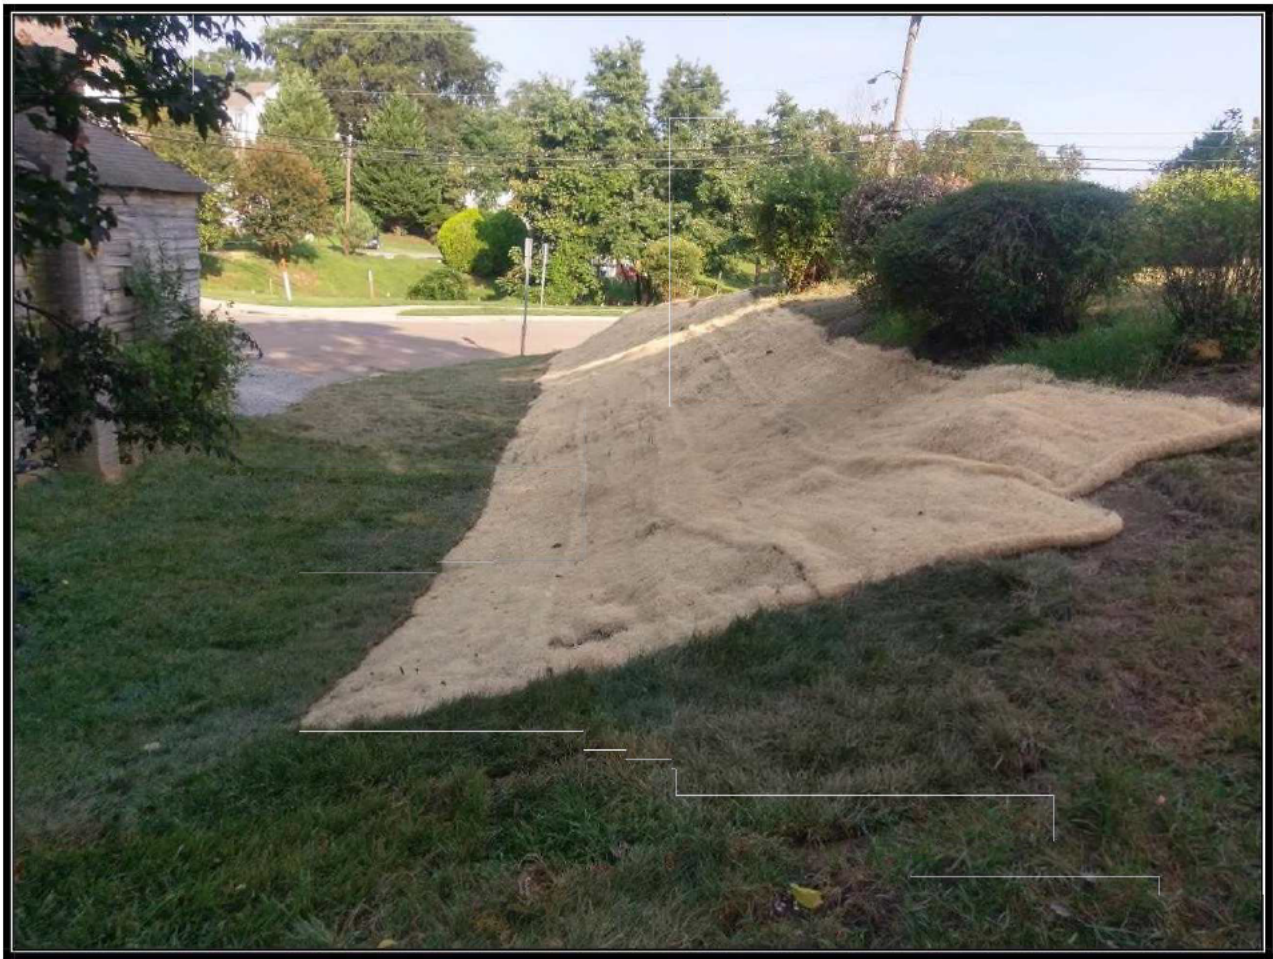
OFFICIAL PHOTOGRAPH NO. 7
U.S. ENVIRONMENTAL PROTECTION AGENCY

Subject: ER installed straw matting, grass seed, and sod in the excavated areas after backfill and topsoil were in place.

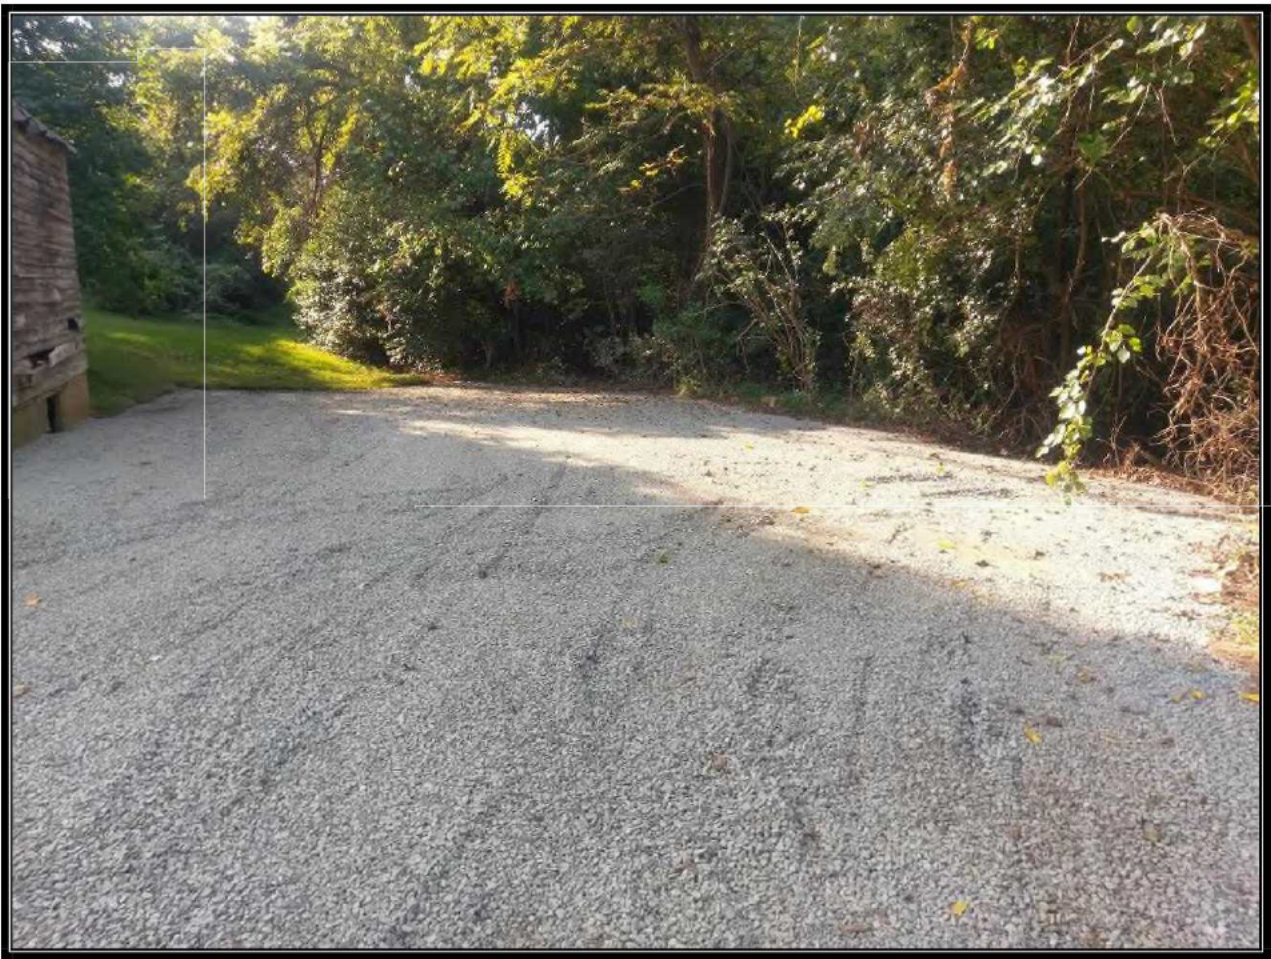
TDD Number:	TT-01-071	Location:	Davidson Asbestos
Orientation:	West	Date:	August 21, 2017
Photographer:	Paul Prys, Tetra Tech	Witness:	None
Subject:	ER installed two layers of rock in the southern excavated area after backfill was in place.
